UT to Dixon Branch

Site 16

Photo Point #3 (Upstream)
Year 1 Summer - September 2009

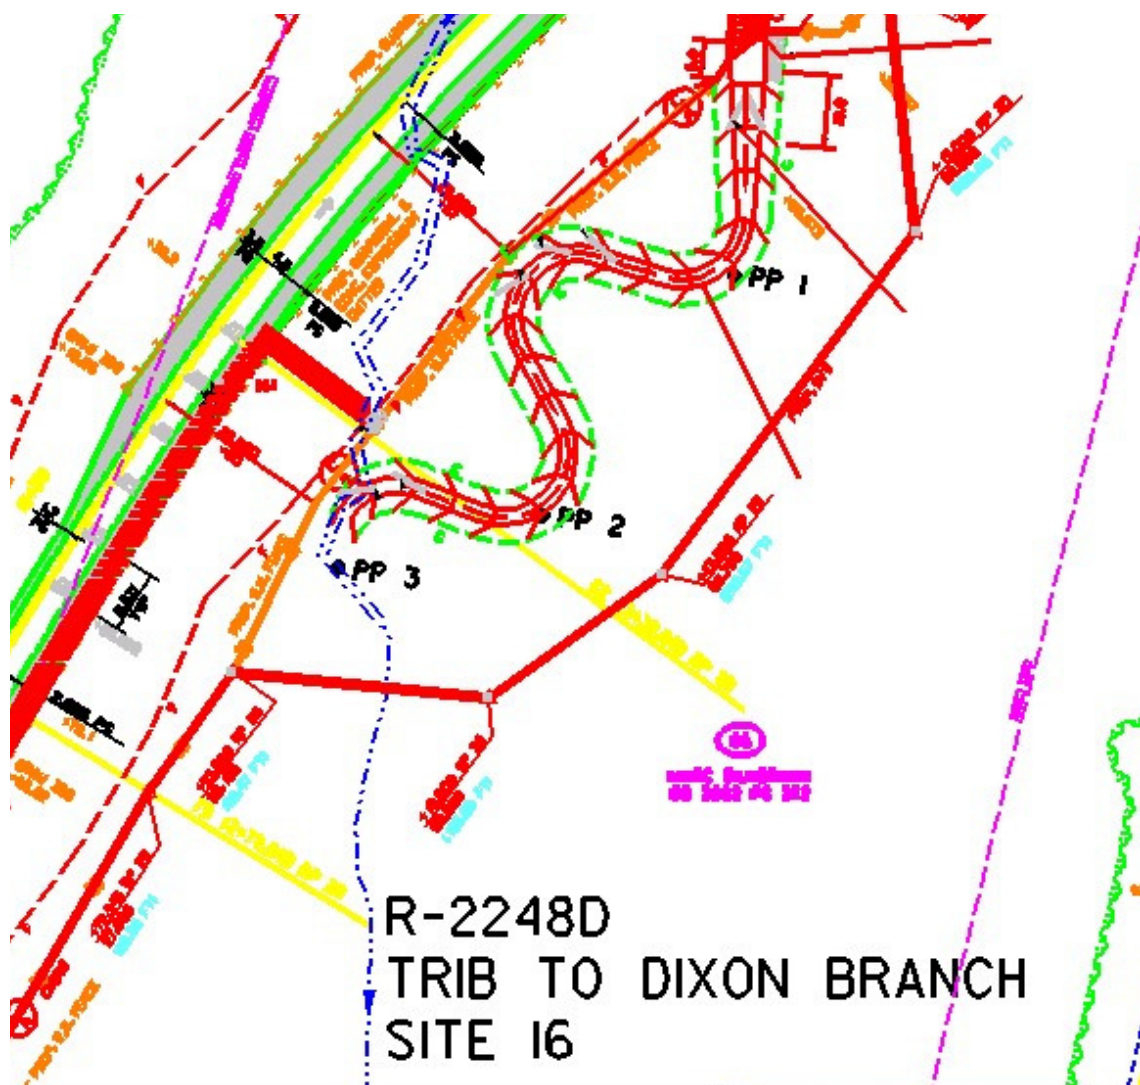
UT to Dixon Branch (Site 16) stream relocation is experiencing some instability for the Year 1 Summer evaluation. A headcut noted during the last evaluation at Sta. 13+30 Ramp 2D which was downstream of Photo Point #2 has moved upstream of Photo Point #2 to Sta. 13+50 Ramp 2D. There is still some bank erosion on the left and right banks due to the head cut that has formed upstream. This bank erosion is at Sta. 13+20 Ramp 2D (Photo Point #3 Up and Downstream Photos). A bankfull event had occurred since the last monitoring evaluation. NCDOT is in the process of repairing the stream bed and banks at this time and will continue to monitor this stream relocation.

(Additional Photo of headcut upstream of
Photo Point #2)
